PERFORMANCE EVALUATION OF AUTOMOTIVE
WHEEL BEARING GREASES

FINAL REPORT

SKF INDUSTRIES, INC. REPORT NO. AT84T004

SKF TECHNOLOGY SERVICES
1100 FIRST AVENUE
KING OF PRUSSIA, PA

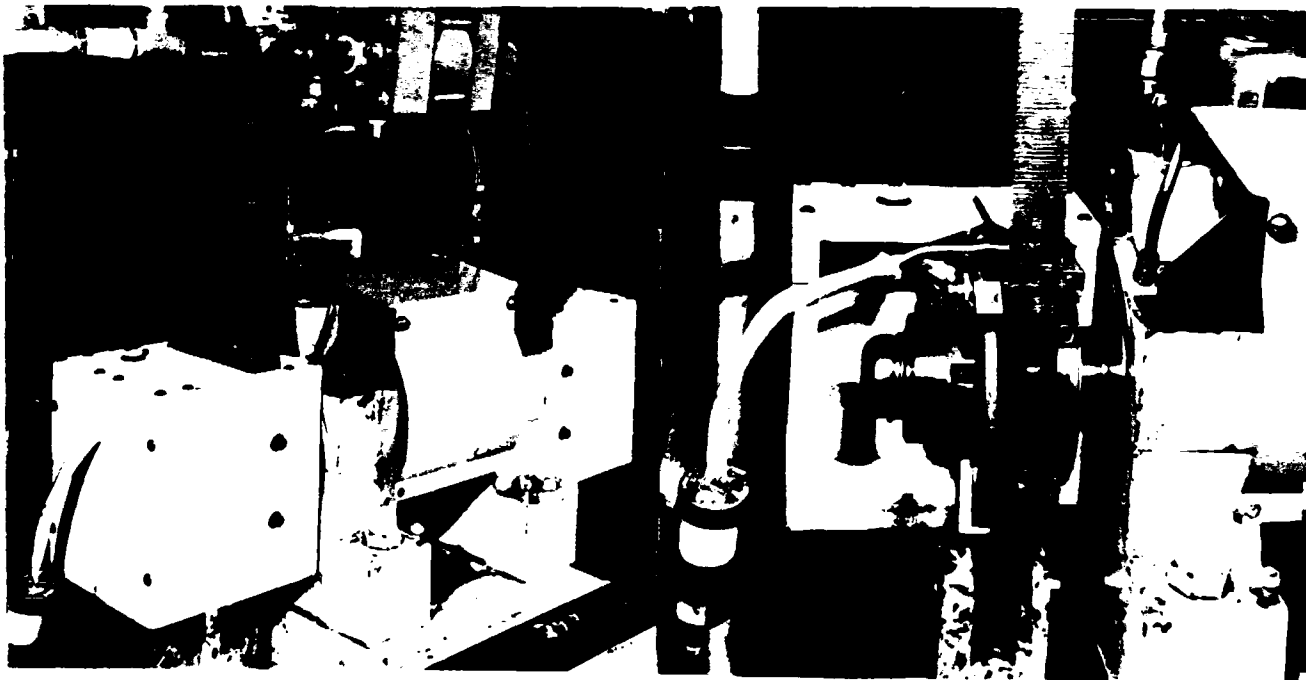
Test Machine

The basic configuration of the test machine consists of a centrally belt driven horizontal arbor which is supported by two cylindrical roller bearings. Photographic views of the machine are shown in Figure 1. A hub containing a pair of tapered roller bearing test specimens is mounted on each end of the arbor as shown in the assembly drawing of Figure 2. A constant radial force is applied to each hub assembly by a dead weight through a lever and linkage arrangement. A thrust force is applied inward by an air cylinder mounted between the hubs at a prescribed distance from the bearing axis. This offset simulates a cornering force on the hub assembly as would be produced at the tire periphery when a car turns. The thrust force is applied cyclically every five minutes for 1-1/2 minutes duration.

The bearings were run in an artificially heated environment created by a Chromalox 500 Watt ring heater, fastened to the side of the load arm, and surrounding the hub as shown in Figure 2. The heater provided the additional heat, over and above that caused by internal bearing friction, to bring the bearing temperature to the required level of operation. Power to the dual element heater was adjusted manually through a Powerstat. One element of the heater was on constantly and supplied that amount of heat needed to bring the operating temperature of the test bearings to within 10 to 15 K of the specified level. The second element, powered through the same Powerstat, and automatically controlled by a Chromalox temperature controller maintained the bearing temperature at the prescribed

(a) Overall View

(b) Enclosed Test Head

(c) Test Hub and Heater

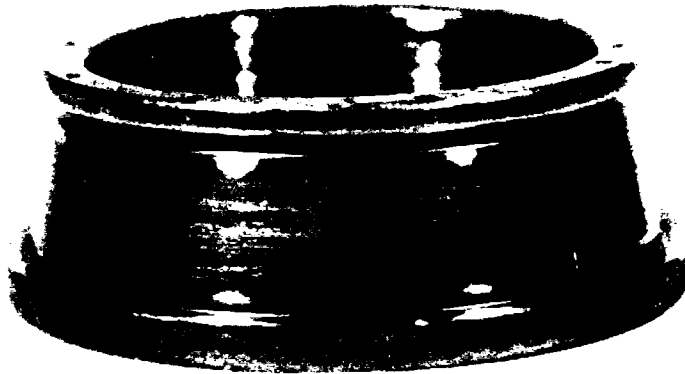
FIGURE 3

EXAMPLES OF VISIBLE DAMAGE TO CONE ROLLING CONTACT SURFACES

Cone Surface - Macrosurface Distress

Cone Surface - Spall and
Macrosurface Distress

The degree of microwear occurring can be qualitatively estimated by comparing the SEM micrographs of the run surface with that of a new surface. Generally, if the lines generated by the manufacturing processes remain, the microwear is considered minimal or slight. As the wear process progresses, the lines become less distinct; but as long as some lines are evident the microwear can be considered as being within acceptable limits. When the lines are obliterated, the wear is significant; and the internal geometry can be detrimentally altered. A microspalled surface will eventually generate the exfoliation of larger areas which will ultimately result in the total failure of the bearing surface as shown in Figure 3.

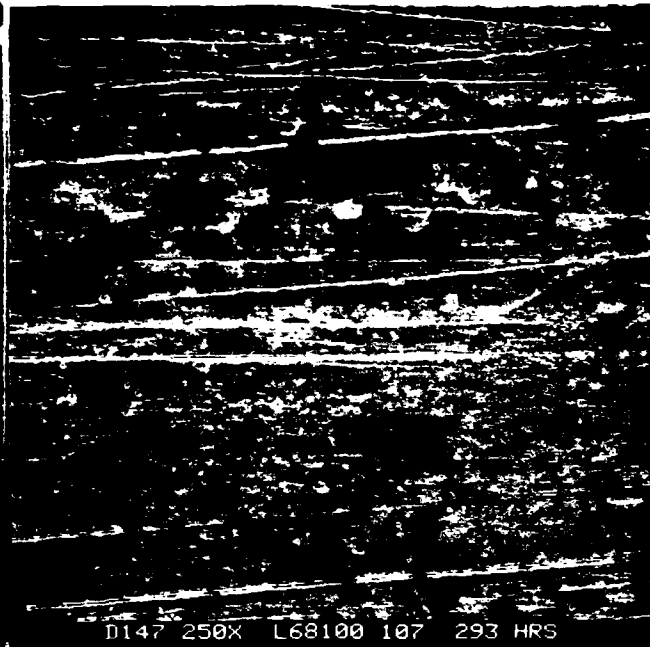
FIGURE 6
POST TEST CONDITION OF TEST BEARINGS
SEM PHOTO MICROGRAPHS

GREASE A

HOURS RUN 293

SEM photomicrographs of typical bearings from each grease group are presented in Figures 5 to 14. Where possible unfailed bearings were chosen which had completed 300 hours of operation. In those instances, i.e., Grease E where none of the bearings had completed 300 hours, the longest lived bearings were chosen. In this case, the surfaces shown were debris damaged and/or spalled.

SEM photomicrographs - Cone surfaces have few honing lines indicating moderate wear; and are macro spalled.

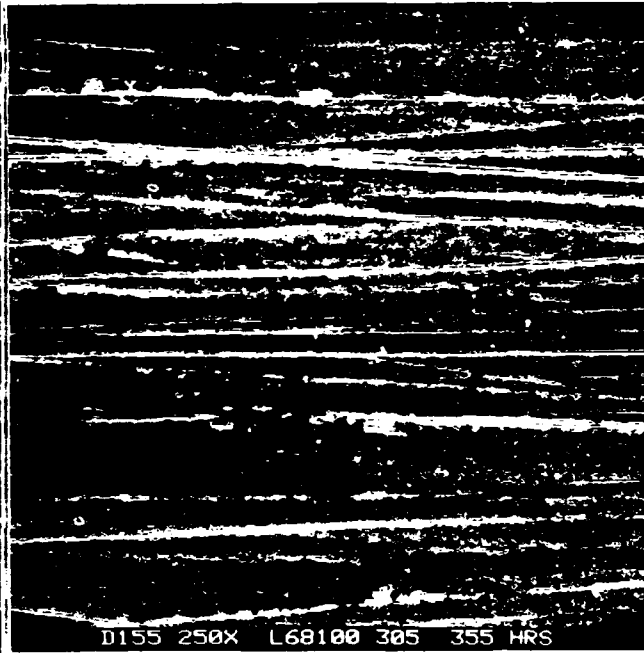
FIGURE 10
POST TEST CONDITION OF TEST BEARINGS
SEM PHOTO MICROGRAPHS

1000X
LM12700 (OUTBOARD BRG.)
GREASE C
HOURS RUN 355

1000X
L68100 (INBOARD BRG.)
BEARING SET 305
MIL REVS 17.0

SEM photomicrographs - Cone contacts devoid of honing lines, are severely damaged and worn.

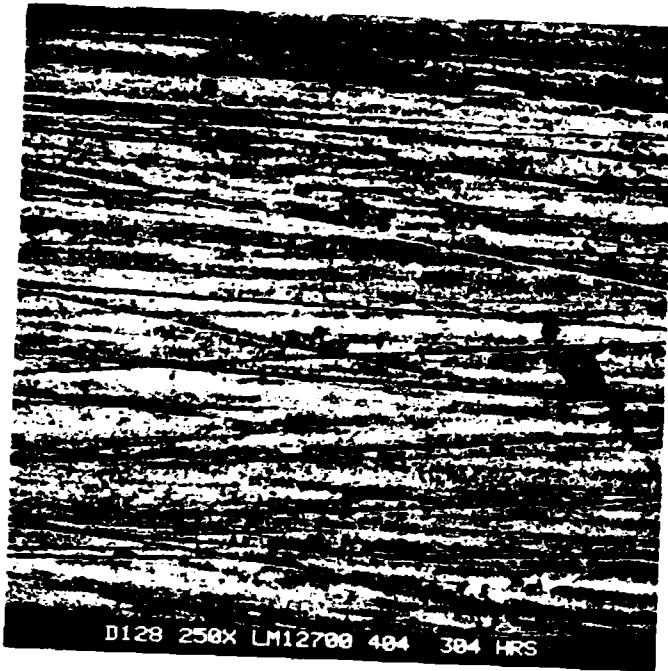
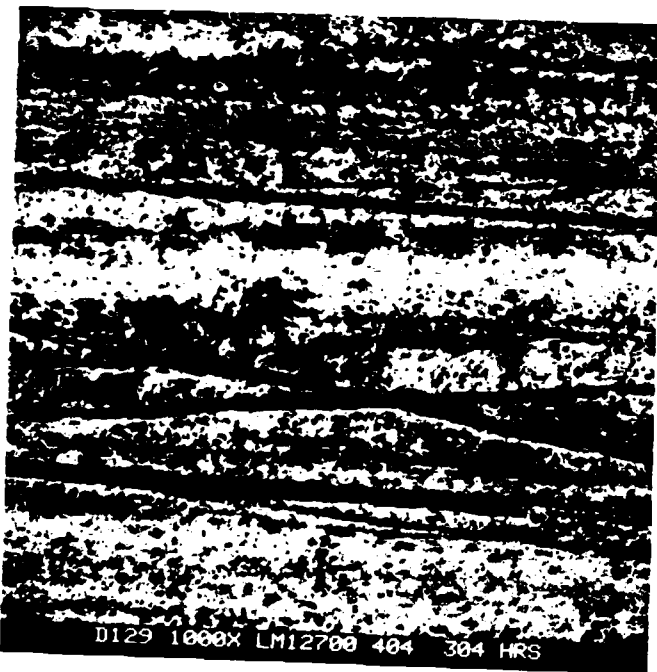
FIGURE 12
POST TEST CONDITION OF TEST BEARINGS
SEM PHOTO MICROGRAPHS

GREASE D
HOURS RUN 304

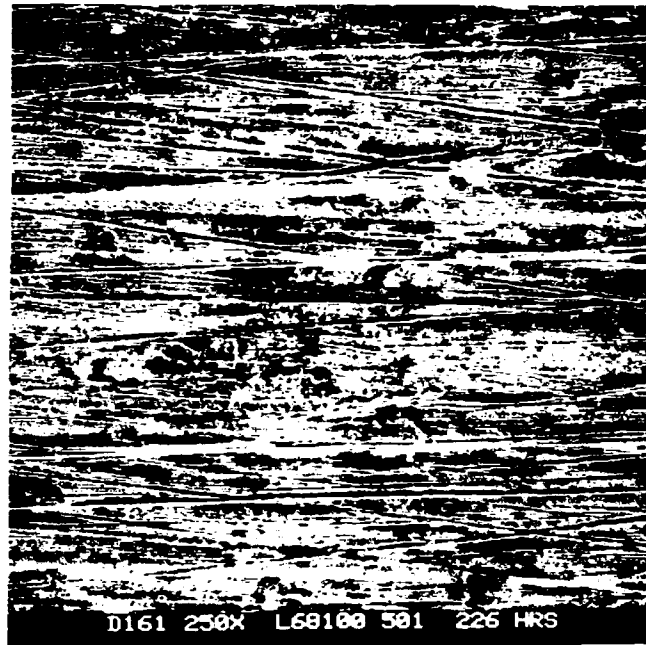
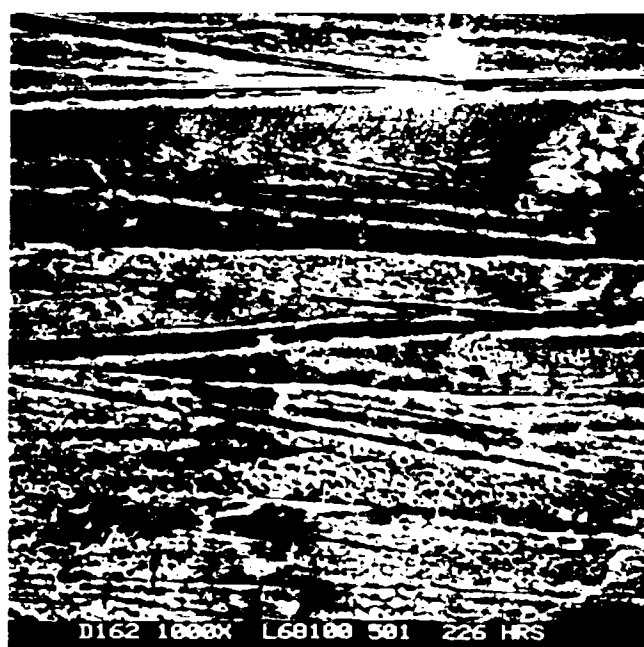
FIGURE 13
POST TEST CONDITION OF TEST BEARINGS
SEM PHOTO MICROGRAPHS

GREASE E

HOURS RUN 226
